SIRWEC 2012

Daniel Crevier
Eastern Canada Manager, Weholite products
KWH Pipe Canada LTD
Québec, Canada

MTQ save millions \$ by relining culverts with long life spend pipes

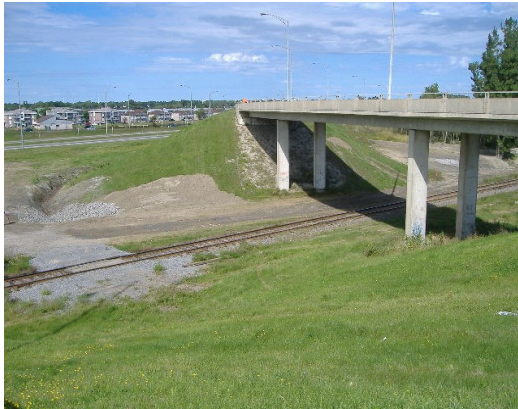
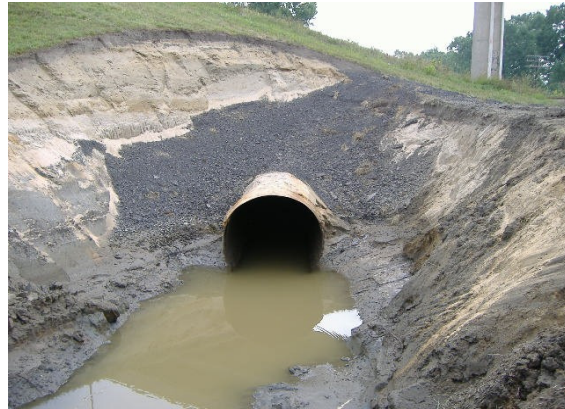
The pictures above shows a culvert under an asses road to an autoroute next to a rail way. The wrinkle metal culvert was rusted, in fact, bottom less and letting in the soil support at an alarming rate. It was determined that the cost of dig and replace would have been well over \$1,500,000.00 and would have taken months to do the extensive work. The economic cost, of stopping the traffics of the road and the railway, was also in the Millions \$. An assessment of relining with Weholite was then taken in consideration. The first step is to determine the largess size of pipe that can be pulled in the existing culvert. The second step is to verify and evaluate if the reline pipe can and will handle the new 100 year storm data.
