Monitoring slipperiness on walkways

Marjo Hippi Finnish Meteorological Institute

23rd May 2012

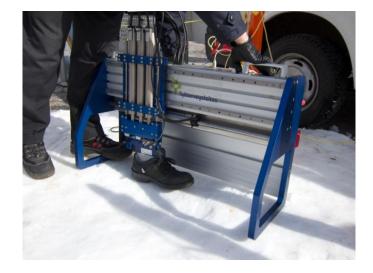
Slipmeter developed by Finnish Institute of Occupational Healthy

- Simulates stepping
- Different footwear can be tested
- Different stepping force can be tested
- As a result: friction between surface and shoe sole

FIOH's slipmeter

- Good device to measure slipperiness on walkways
- Uneven surface disturbs consecutive measurements
- Cannot be used operationally

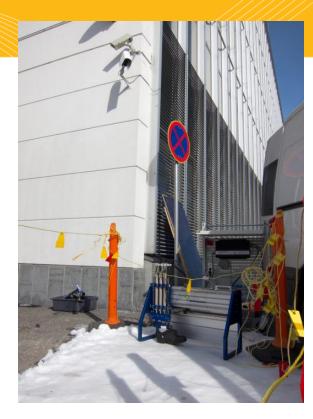
Measurements between DSC111 and FIOH's slipmeter on 17th March 2011

- Snow was taken to the test site and packed by stepping day before
- Two shoe soles were tested with the slipmeter
 - A: shoe sole with good grip
 - B: very slippery shoe sole (like curling shoe)

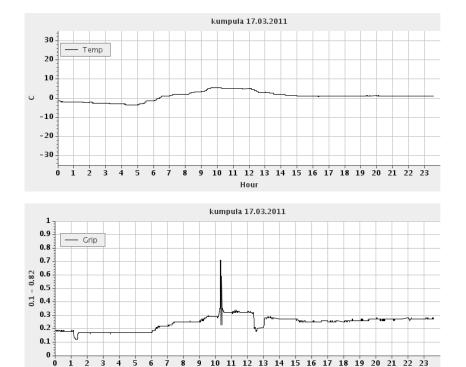
Measured friction was around 0.3 with shoe A and DSC111 instrument

Friction measured by DSC111 (error peak caused by people on the test site)

- Easy to install and use
- Gives continuously low values for friction in case of lot of ice on the surface
- In case of thin layer of ice more reliable results
- Affect of gritting unknown
