Observing the variability of road and weather conditions with hybrid mobile and fixed sensors

ColdSpots studied dangerous road stretches

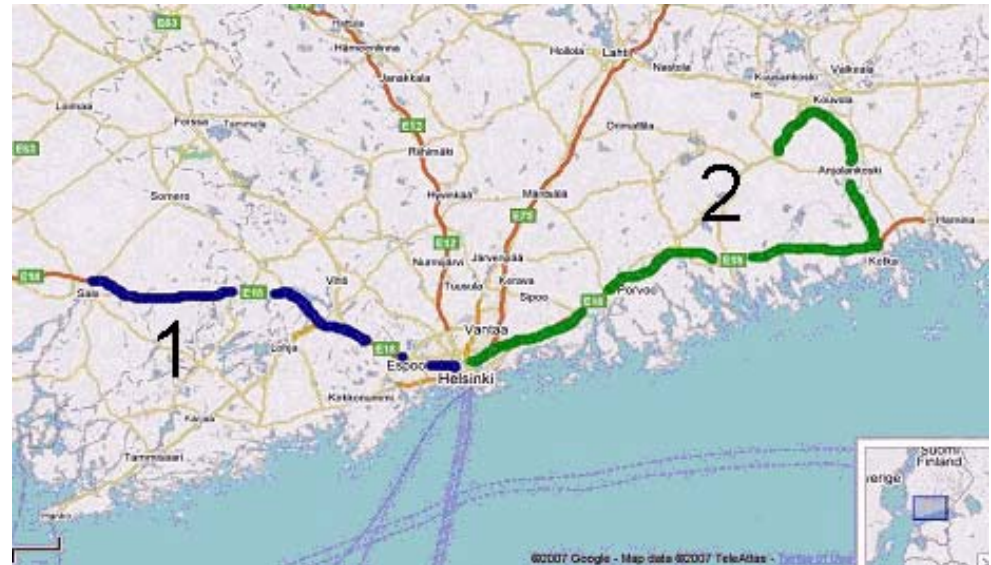
ColdSpots mobile measurements

- Eleven cases measured in January-February 2007

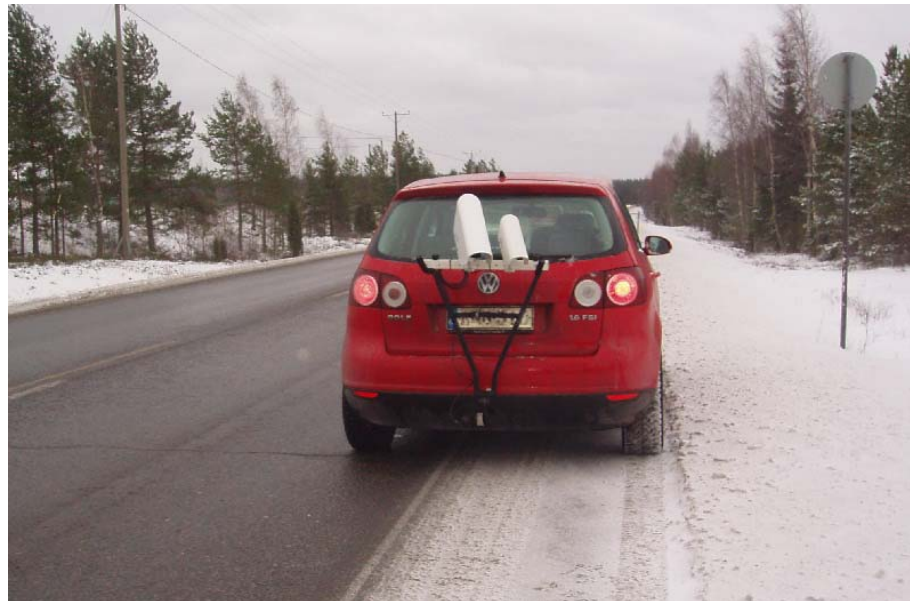
Mobile measuring unit

- Vaisala DSC111 and DST111 mounted behind a car
- Palm-sized measuring area few meters behind the right wheel. Average length of one measurement ca. 130 m
- DSC111: Amount of ice, snow and water on the road => friction
- DST111: Road and air temperature, air moisture

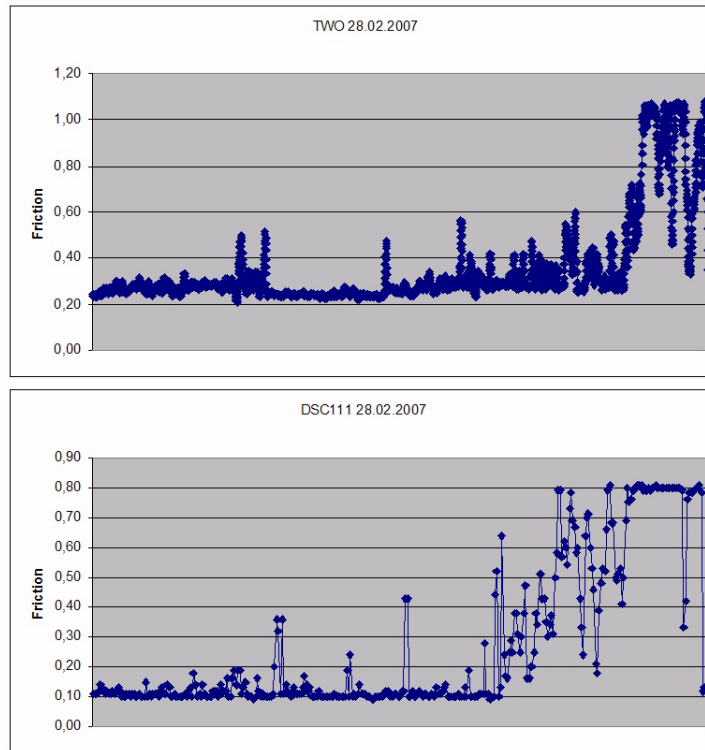
Comparison measurements

- DSC111 and TWO friction wheel compared. Very similar results but slightly different measuring ranges

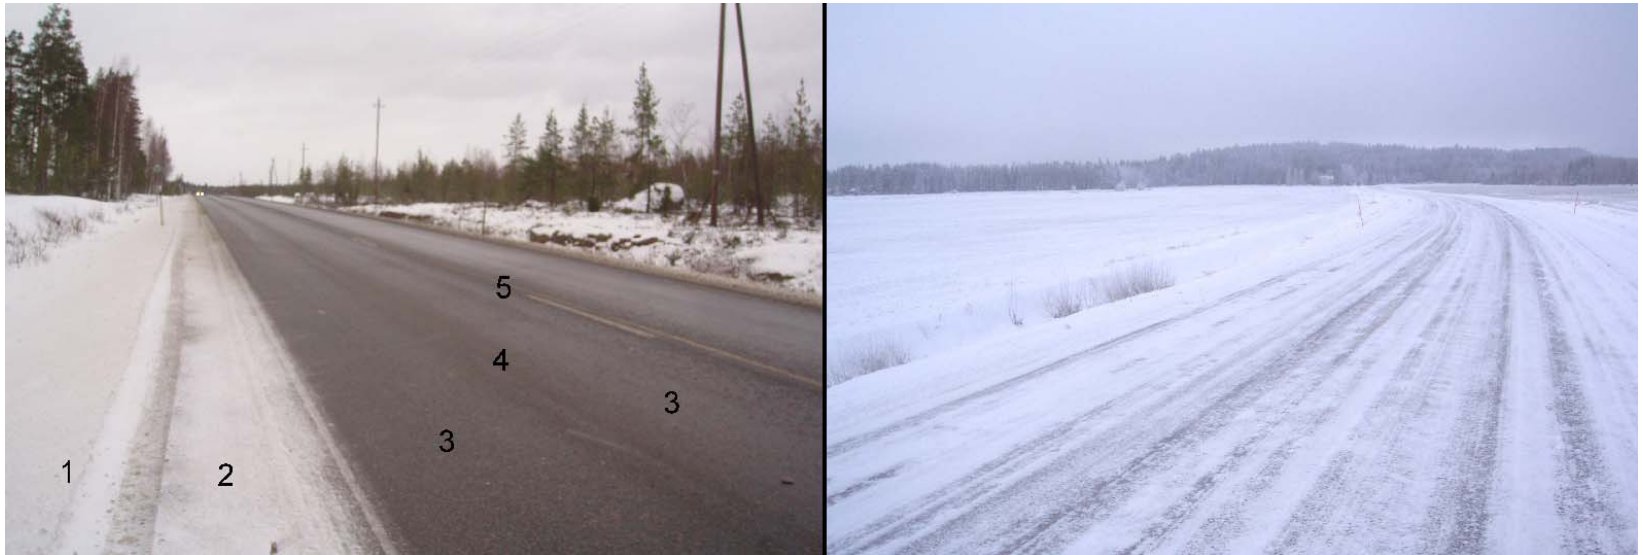
Friction across the road

- Friction may vary considerably across the road or on different roads on a same day
- Measuring and analysing friction on the road network is a very complicated issue!

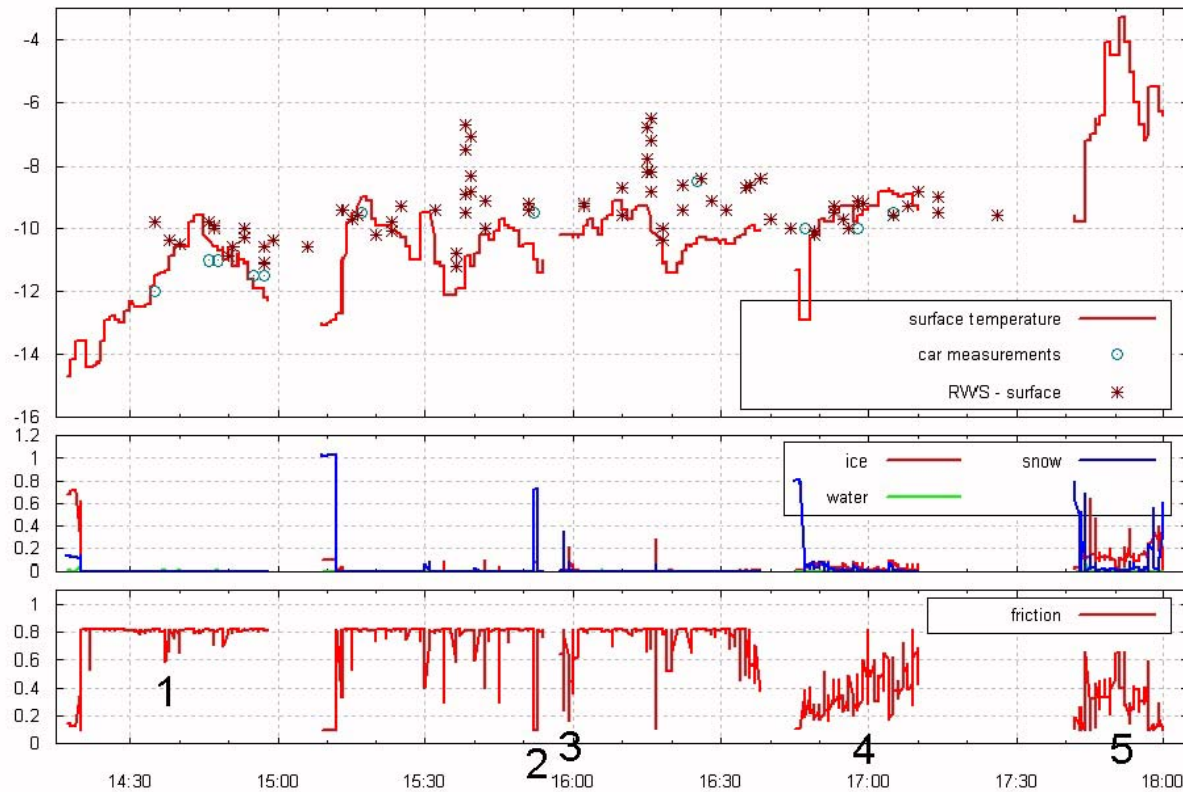
Case: Cold slippery and snow 23.01.2007 Vt 1

1 = bridge, 2 = roadside, 3 = passing lane, 4 = snowfall, 5 = city

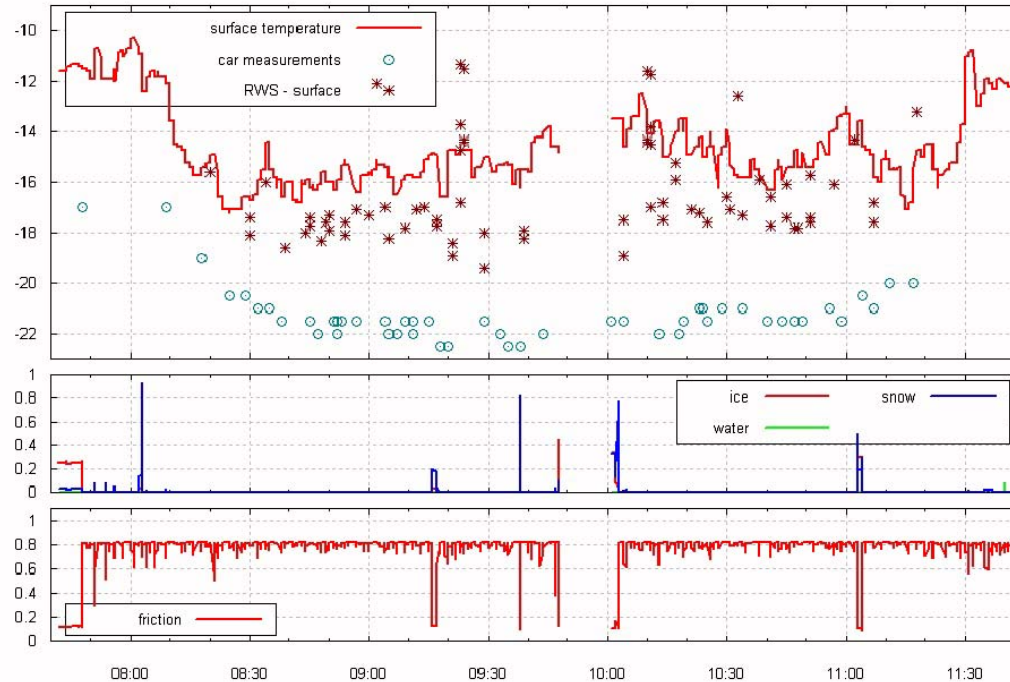
Case: Cold slippery 06.02.2007 Vt 1

- Friction mostly good, low values only on road sides
- Road body temperature high due to very warm previous day. This explains warmer DST111 measurements

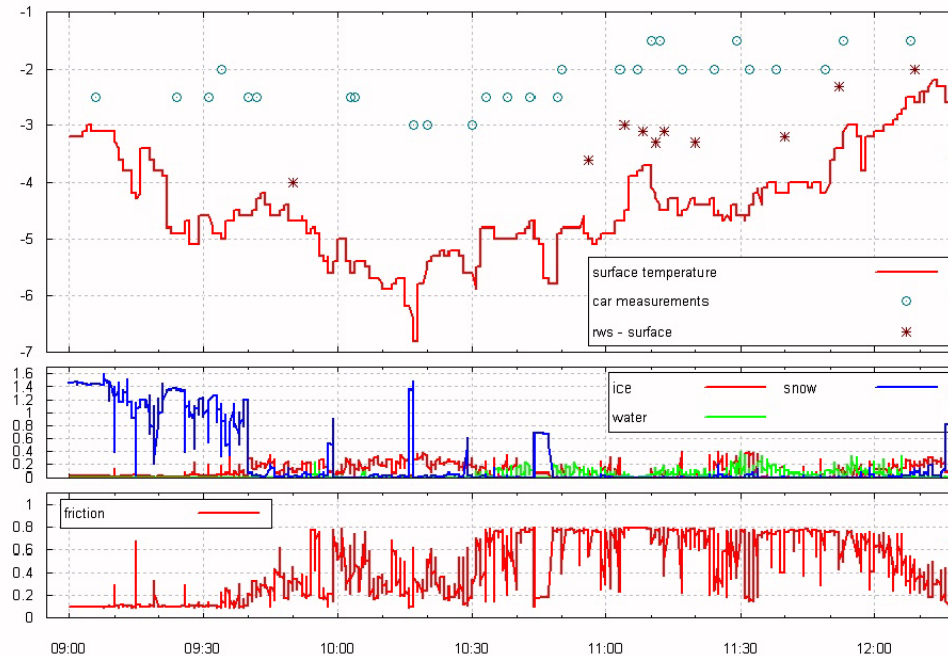
Case: Thawing and snowing 26.01.2007 Vt6 and Vt7

- Low friction on the left is local snow packed road.
- Road body temperature cold shown in DST111 measurements
- Accumulated snow and water on the right during heavy snowfall

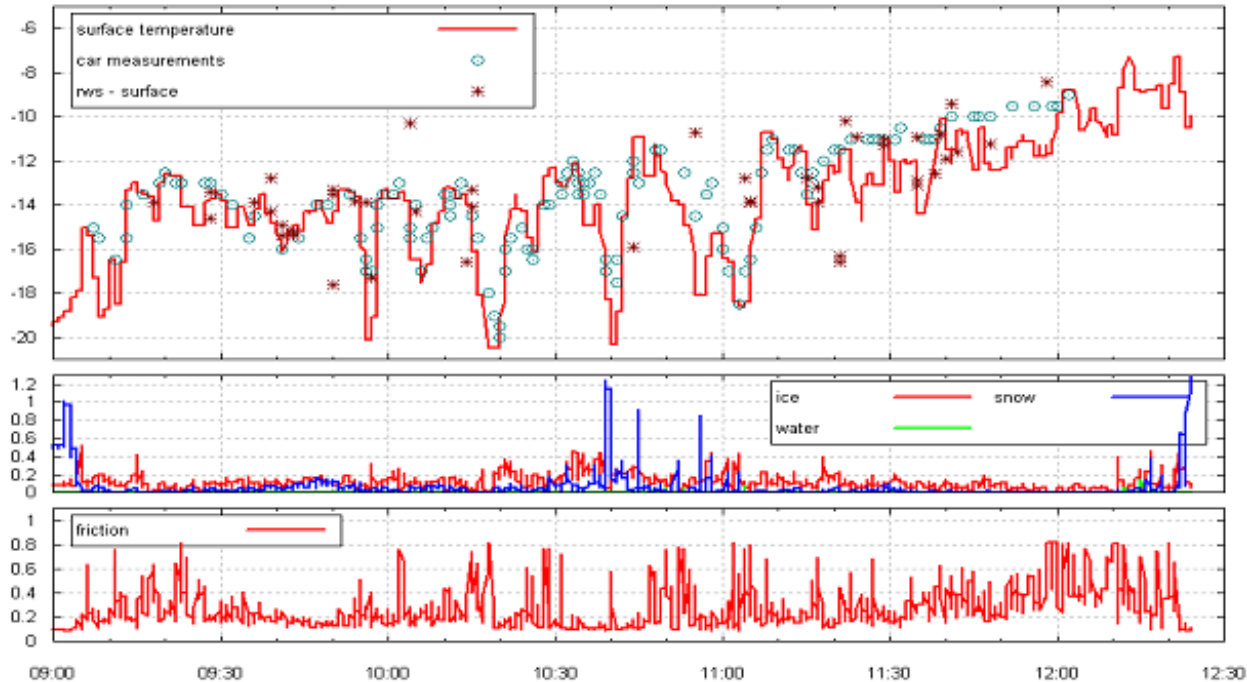
Case: Cold slippery 30.01.2007 - Highway 1

- Morning after very cold and clear night
- Large local variations, cold air pools
- Ice on road, friction dangerously low
